**ADC Solo**

**Path Speed CR SP 1001**

## **New designed Energy Chain of Cassette Unit introduced**

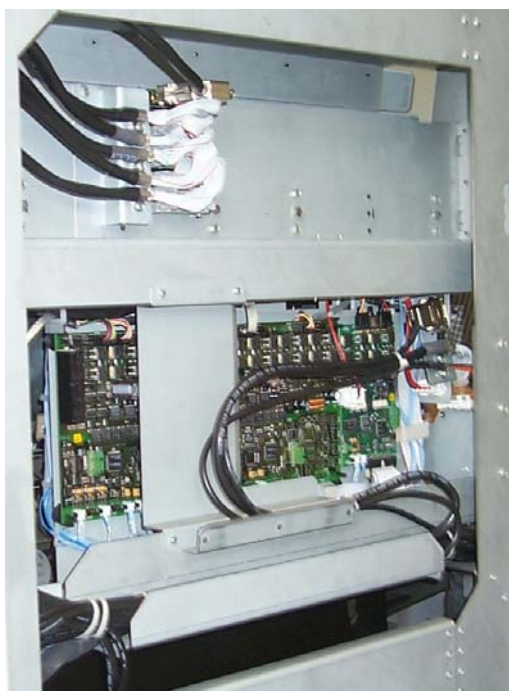
#### Position of the Unit

View from left side with opened housing

Replace the energy chain of the cassette unit by the new one:
